Manhole Inspection Summary

Manhole # S63G__008MH

Insp Date: **3/26/08 9:03 AM**

Location Address: **5100 Bayview Blvd.**

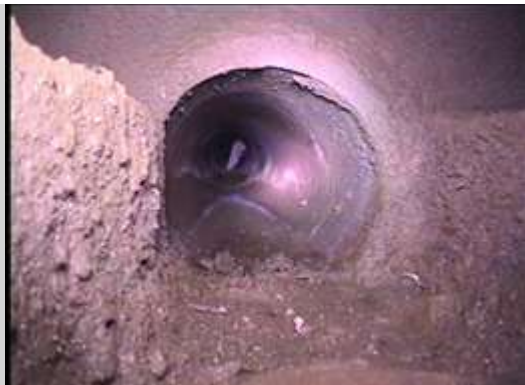
3 O'Clock Inflow

Pipe Height: **8.4** (in.) Rod and Bar (Angled)
Pipe Material: **Clay** ☐ Pipe Lined
Invert Depth: **17.25** (ft.) Flow Characteristics: **None**
Deposits: ☒ None ☐ Mud ☐ Sludge ☐ Debris ☐ Grease
Silt Depth: (in.) Deposits Extent:
Infiltration: **None** Pipe Seal Cond: **Sound**

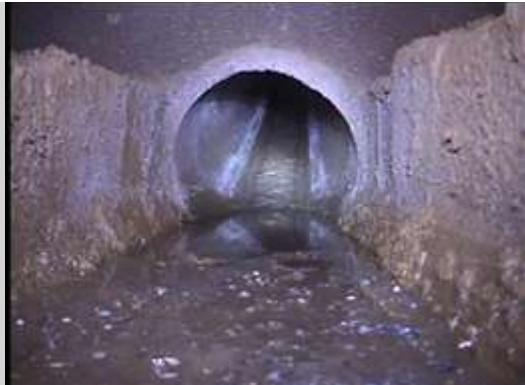
6 O'Clock Inflow

Pipe Height: **8.4** (in.) Rod and Bar (Angled)

Pipe Material: **Clay** ☐ Pipe Lined

Infiltration: **None** Pipe Seal Cond: **Sound**
